PROCESS INSTRUMENT SALES

Customer Reference	Wet Pulp Belt Weigher Refurbishment
Job Number/ Work Order Number	34365
Conducted On	25-08-2020
Conducted By	Craig Mannan
Site Contact	John Smith
Location	123 The Street Nowheresville Glanshire XX3 2Z
Induction Carried Out	Yes

DETAILS OF WORK CARRIED OUT

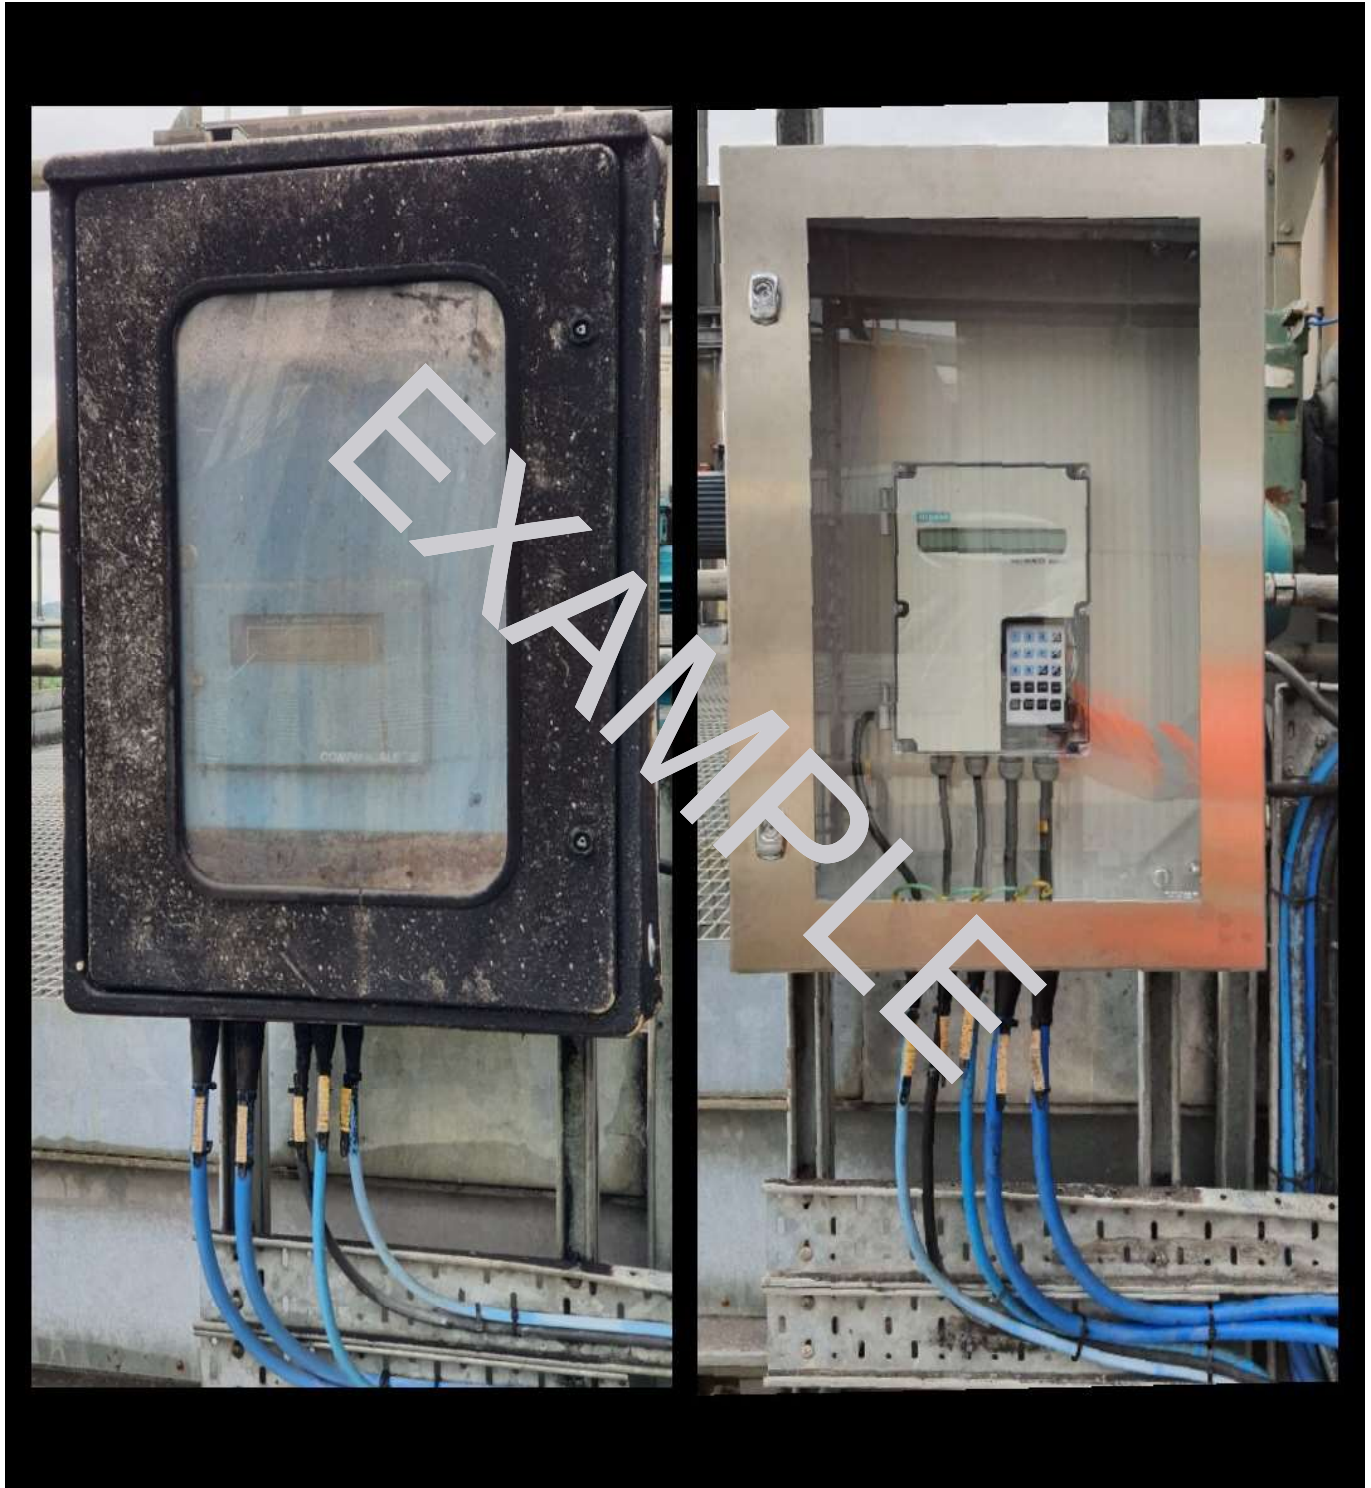
Photo 1

1. Weigh controller enclosure, before & after.
2. Load cells, before & after.
3. Speed sensor.
- 4 to 7. Load Cells Calibration Certificates.

The Milltronics Compuscale II and enclosure was removed and replaced with a new enclosure containing the Milltronics BW500. The cables were pulled into the enclosure, tested for insulation and continuity and then terminated in the weigh controller.
